# Engineering Structures

## Magnetic flux leakage technique to detect loss in metallic area in external post-tensioning systems

Madhu M. Karthik<sup>a,\*</sup>, Tefvik Terzioglu<sup>b</sup>, Stefan Hurlebaus<sup>c</sup>, Mary Beth Hueste<sup>c</sup>,  
Herbert Weischedel<sup>d</sup>, Ronald Stamm<sup>d</sup>

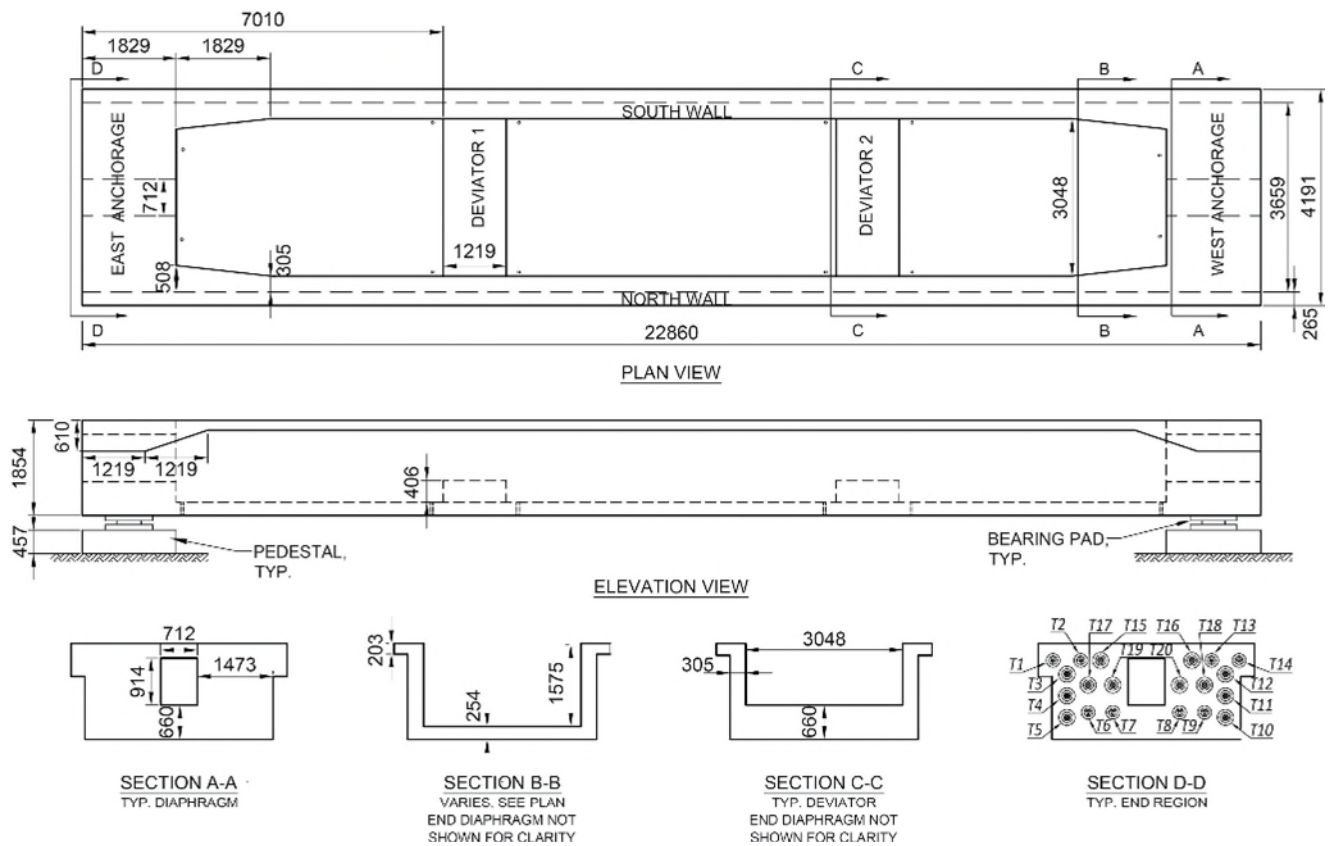
All dimensions in mm

Fig. 2. Layout and cross-sectional details of post-tensioned U-beam girder specimen.

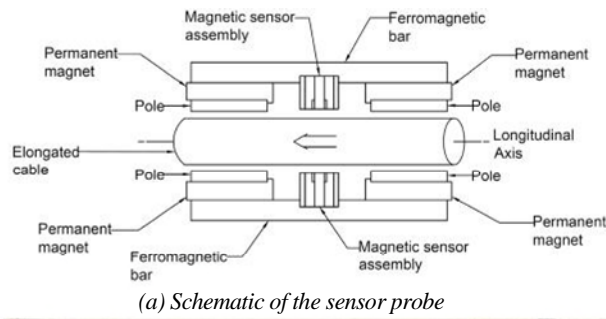
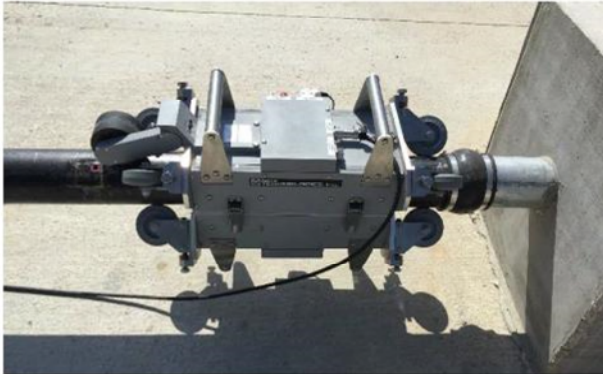
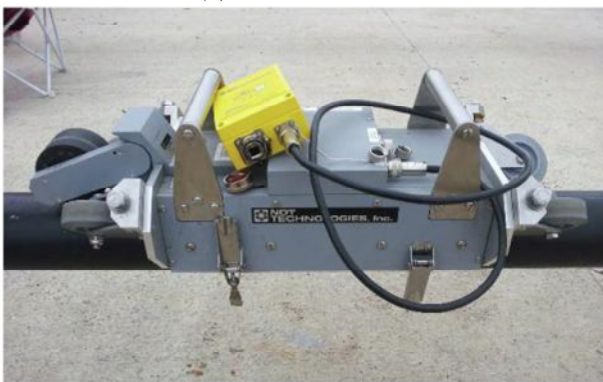
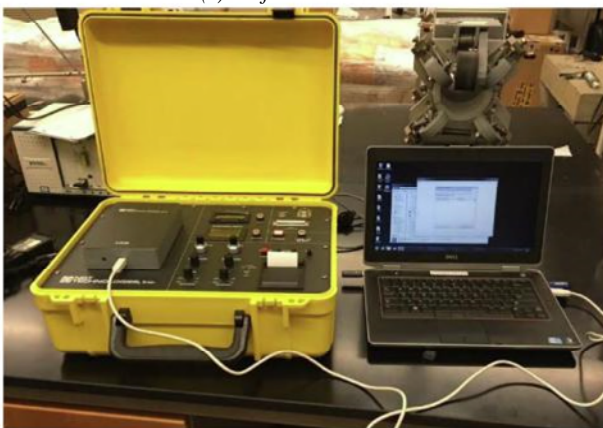
Fig. 3 shows the schematic and photographs of the LMA-450 sensor head along with the CC-04 USB signal console manufactured by NDT Technologies Inc. that was used for the inspection of the external tendons. The LMA-450 sensor head is capable of testing external tendons

Fig. 3. Experimental setup, and components of MFL inspection technique.

The strong permanent magnets in the sensor head are directly used on the external post-tensioning system to magnetize the ferrous material (steel). This induces flux paths in the material between the two poles of the magnet. In regions where there is loss in cross-sectional area of the metal strands, the magnetic field in the material "leaks" from its typical path. A magnetic field detector comprised of coils between the poles of the magnet is sensitive to this change in magnetic field and indicates the leak. A signal console shown in Fig. 3(d) is used to gather data from the sensor head. The signal console consists of a signal conditioning circuitry, integrated chart recorder, an USB port for interface with a computer, and interface circuitry and connectors for both an external chart recorder and an external data acquisition system. The USB port connection may be used to display and store data in a computer.

The full-head and half-head sensor configurations shown in Fig. 3(b) and (c) respectively, may be used for the inspection of the external PT tendons. While the full-head configuration is usually preferred, under actual field conditions it may be difficult or even impossible to wrap the sensor heads around the PT duct due to limited clearance between the external tendons and/or the bottom slab of the girder. In order to address this accessibility issue, in this study, only the half-head sensor is used for the evaluation of the external tendons.

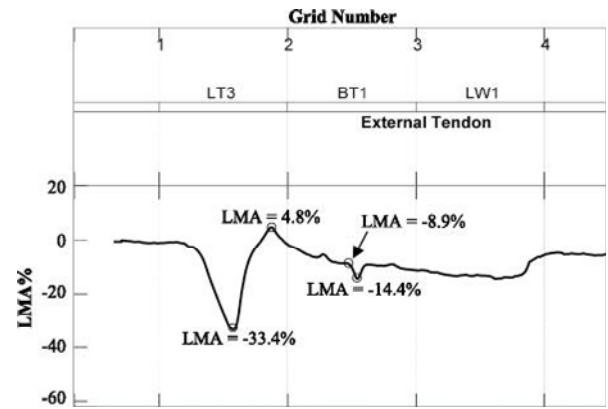
Fig. 4. Validation of data from MFL device with known defects.

adjusting the peak in the LMA signal caused by the known calibration strip to the appropriate increase in cross-sectional area. The rest of the peaks in the inspection data scaled according to the calibration data. To quantify the loss in tendon cross-sectional area, the difference in LMA percentages between the valley and peak observed in the record data are considered. For example, in Fig. 4, the loss in tendon cross-sectional area corresponding to the spike observed at the location of defect LT3 may be quantified as 38.2%, which is the absolute difference between the LMA percentages of -33.4% and 4.8% observed at the peak and valley respectively.

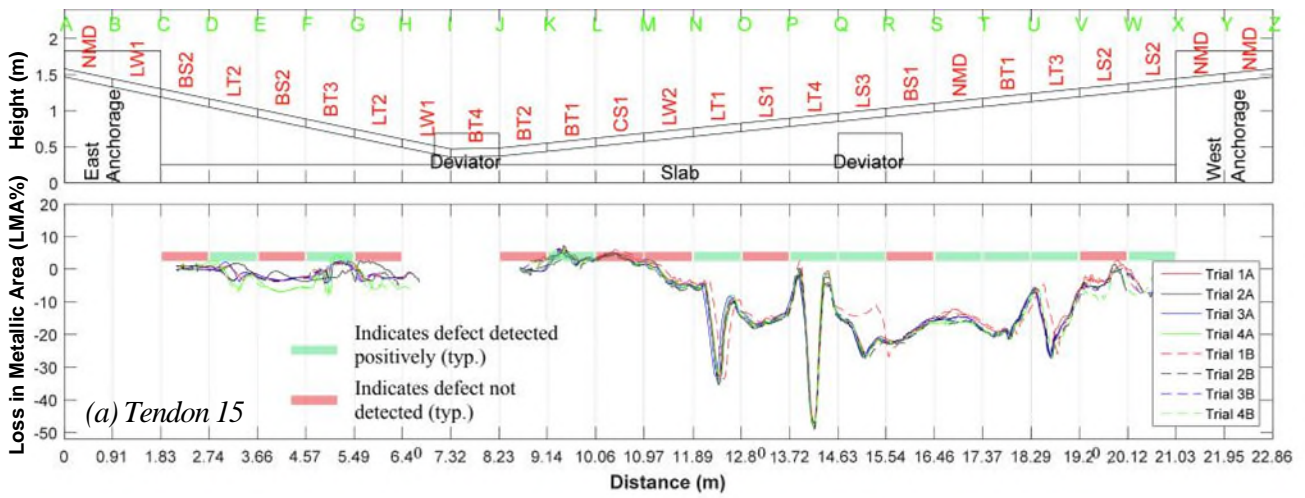
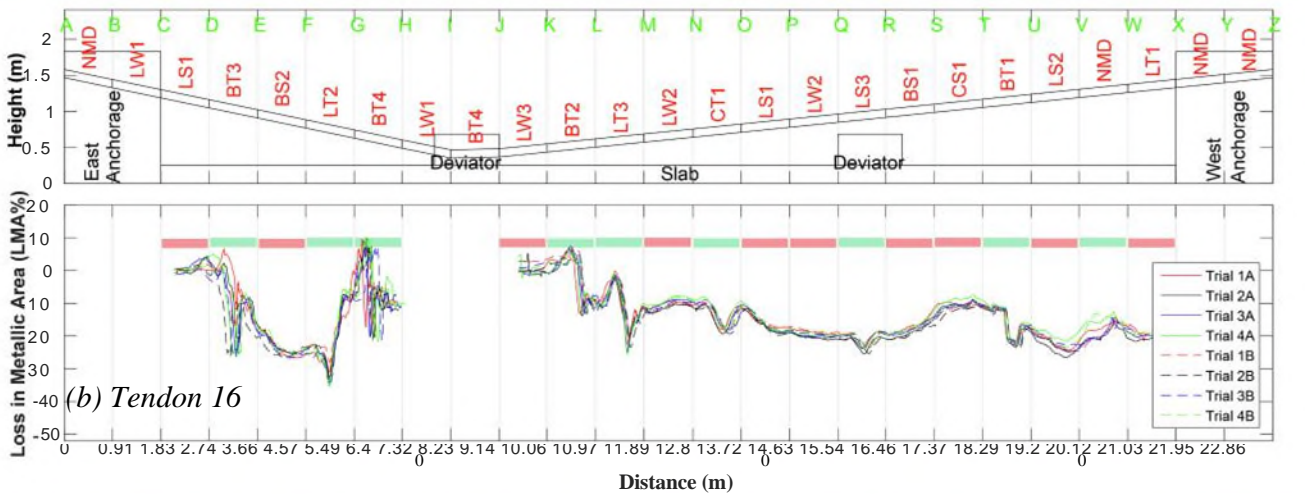
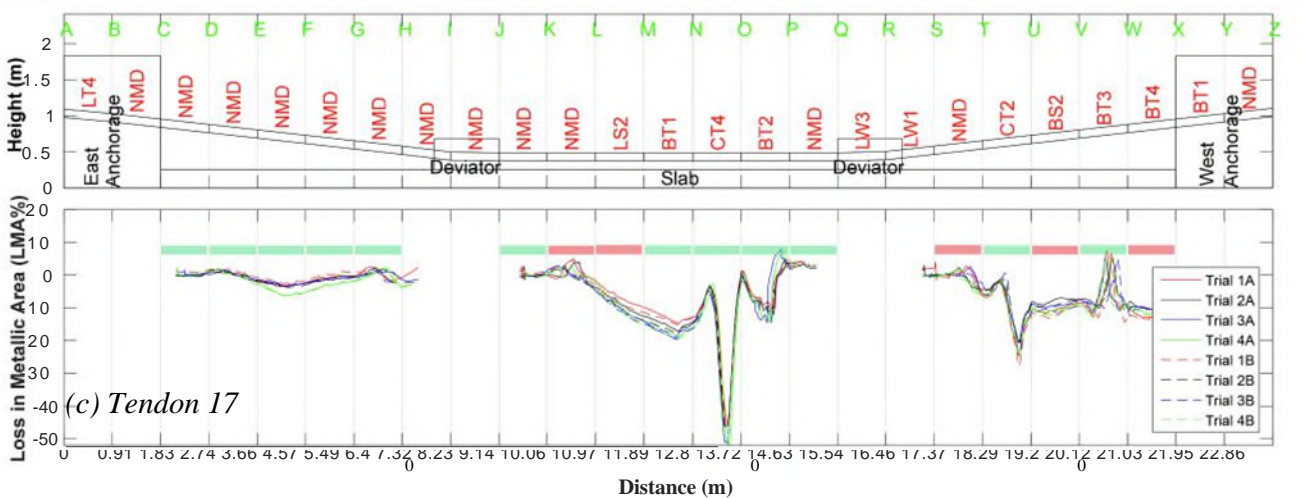
Note: Typical distance between grid points = 914 mm (3 ft). Defect description may be found in Table 1.

Fig. 5. Comparison of results from MFL using half-head sensor with the actual defects-External Tendons 15, 16, and 17.

Figs. 5 and 6 present a comparison of actual defects with the results from the inspection of external tendons of the post-tensioned girder using half-head of the MFL device. The inspection results are evaluated for accuracy in detecting the location of the defect, and the severity of

Fig. 5(a) presents results from all eight trials for external Tendon 15. Due to the presence of the deviator, external Tendon 15 was inspected in two sections, between section C-I and section J-X. However, due to lack of accessibility, the sections close to the deviator (H-I, J-K) could not be inspected. Single-strand breakage BS1 in section R-S and BS2 in section E-F were not positively identified. Single-strand corrosion CS1

in section L-M was also not identified from the inspection results. Similarly, wire section loss LW2 in section M-N, and single-strand section loss LS1 in section O-P were not evident from the inspection results. However, one of the two single-strand section loss LS2 between section V-X could be vaguely identified. All these defects that could not be identified using MFL had a loss in total strand cross-sectional area of less than 5%.

Single-strand section loss LS3 in section Q-R was evident from the distinct peak. Multi-strand section loss LT1 in section N-O, LT3 in section U-V, and LT4 in section P-Q, could all be easily identified from the distinct peaks observed from the inspection results. Multi-strand section loss LT2 in sections D-E is vaguely discernable, however LT2 in section G-H is not identified between the various trials. Multi-strand breakage BT1 in sections K-L, and T-U; and BT3 in section F-G could be identified from the small peaks observed from the inspection data.

Figs. 5(c) and 6(a) show a positive LMA percent in section V-W of Tendon 17 and section U-V of Tendon 18, indicating an apparent increase in metallic area. This observation is consistently made between the various trials. It is to be noted that in between sections V-X in Tendon 17 and T-V in Tendon 18, there were multiple 914 mm long strand sections that simulate a broken tendon. During the placement of the strands in these sections, it is likely that the smaller 914 mm long strand sections could have slightly displaced from their intended location before the placement of the sealant. This could be the possible reason for the net increase in metallic cross-sectional area in the adjacent region.

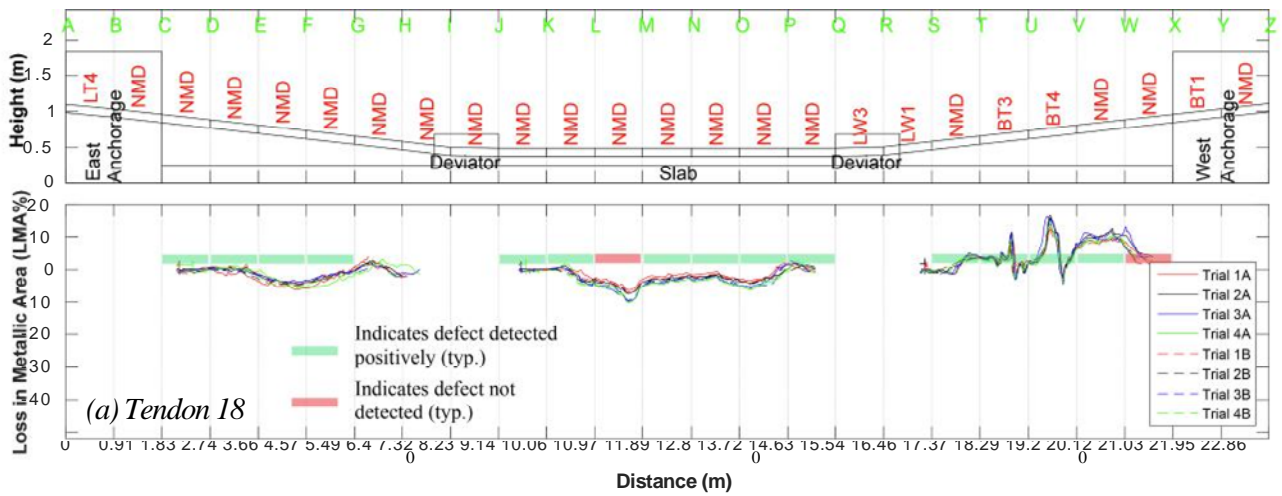
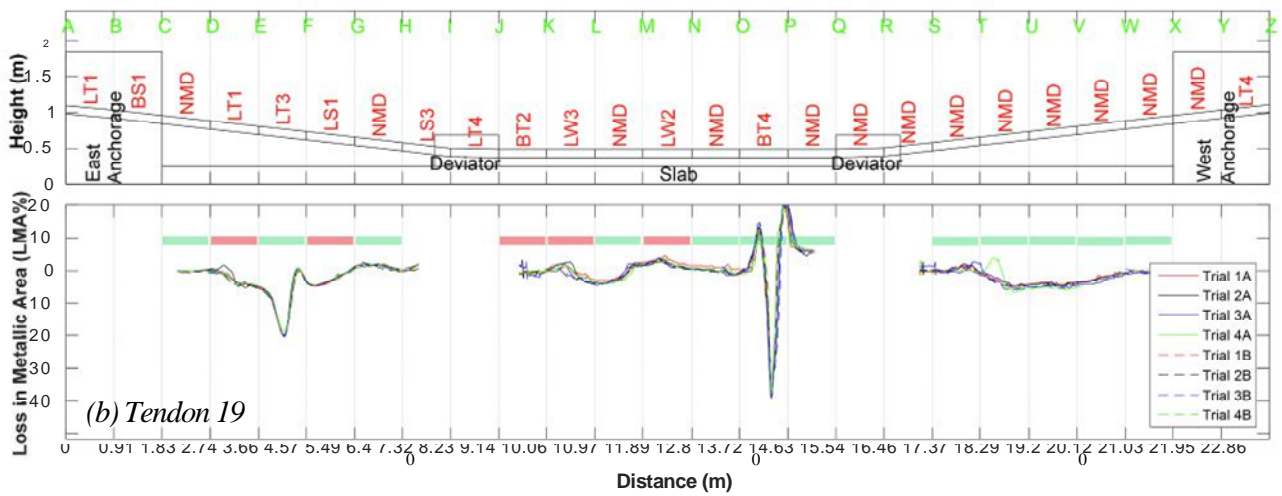
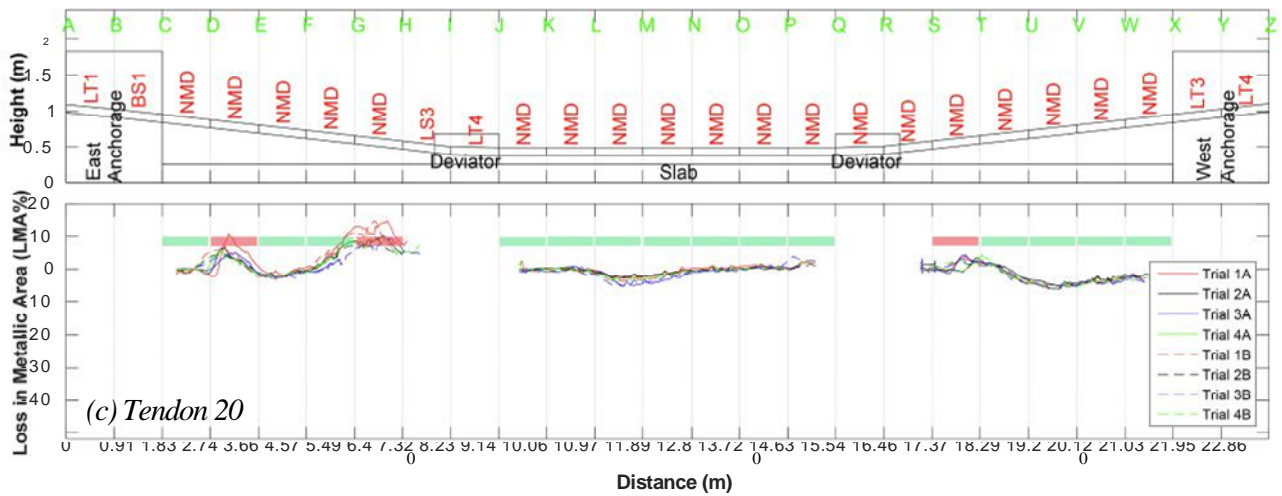
Note: Typical distance between grid points = 914 mm (3 ft). Defect description may be found in Table 1.

Fig. 6. Comparison of results from MFL using half-head sensor with the actual defects-External Tendon 18, 19, and 20.

Similar results with a few exceptions are observed from the inspection results of the remaining external tendons. Owing to the large number of defects in the external tendons, the results are not discussed individually, but are shown in Figs. 5 and 6.
